**S.E. Korkin**

Nizhnevartovsk State University, Nizhnevartovsk, e-mail: [egf\\_nv@mail.ru](mailto:egf_nv@mail.ru)

## Dynamics of the River Channel Deformations along the Latitudinal Section of the Middle Reaches of the Ob River

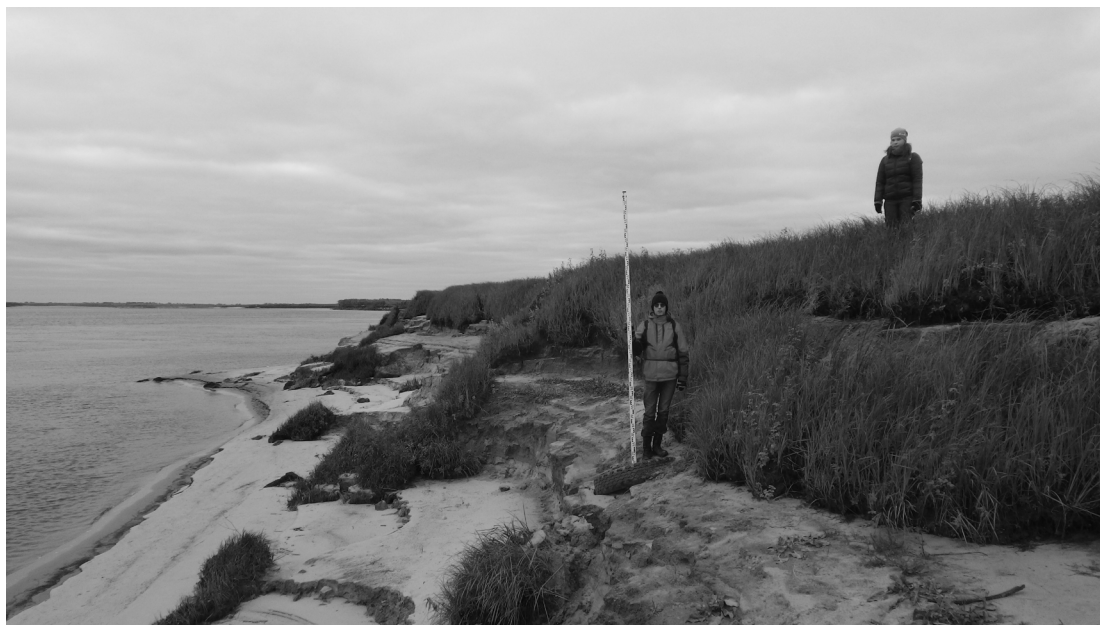
**Figure 3.** Reference No. V in 2017 with the maximum washout of 17 m/year.
